## Case Report

# Inappropriate Protocol of Implant Placement in Contact with Impacted Teeth Leading to Failure

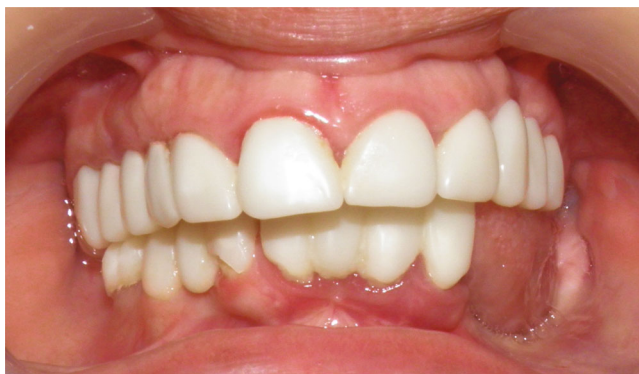
FIGURE 1: Intra-oral image showing full coverage provisional restorations with poor oral hygiene, mandibular partial edentulism with knife-edge residual ridge.

Oral examination showed a unilateral partially edentulous mandibular arch (Kennedy class II) with a knife-edge residual ridge, a lack of keratinized gingiva, and generalized gum inflammation. Provisional crowns were made with adequate vertical dimensions of occlusion but with a compromised aesthetic result (Figure 1).

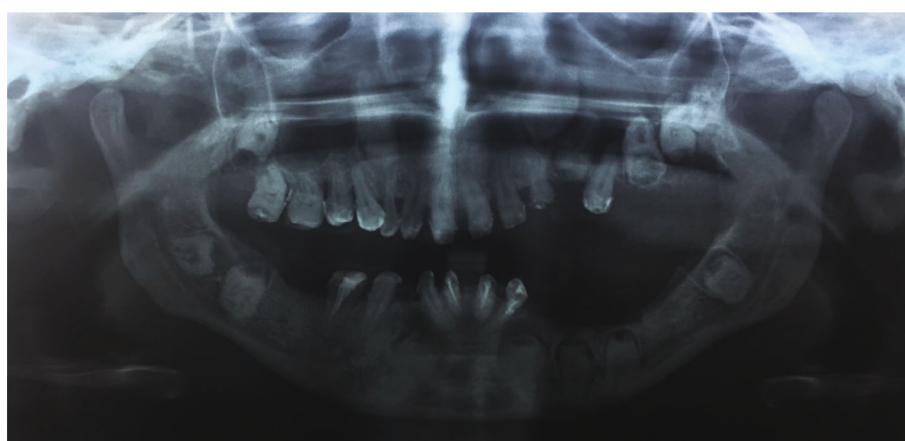
FIGURE 2: Panoramic radiograph showing deeply impacted multiple teeth and severe alveolar ridge deficiency in the left lower mandibular arch.

As shown in Figure 2, radiographs revealed the presence of multiple deeply impacted teeth and a severe alveolar ridge deficiency in the left lower mandibular arch.

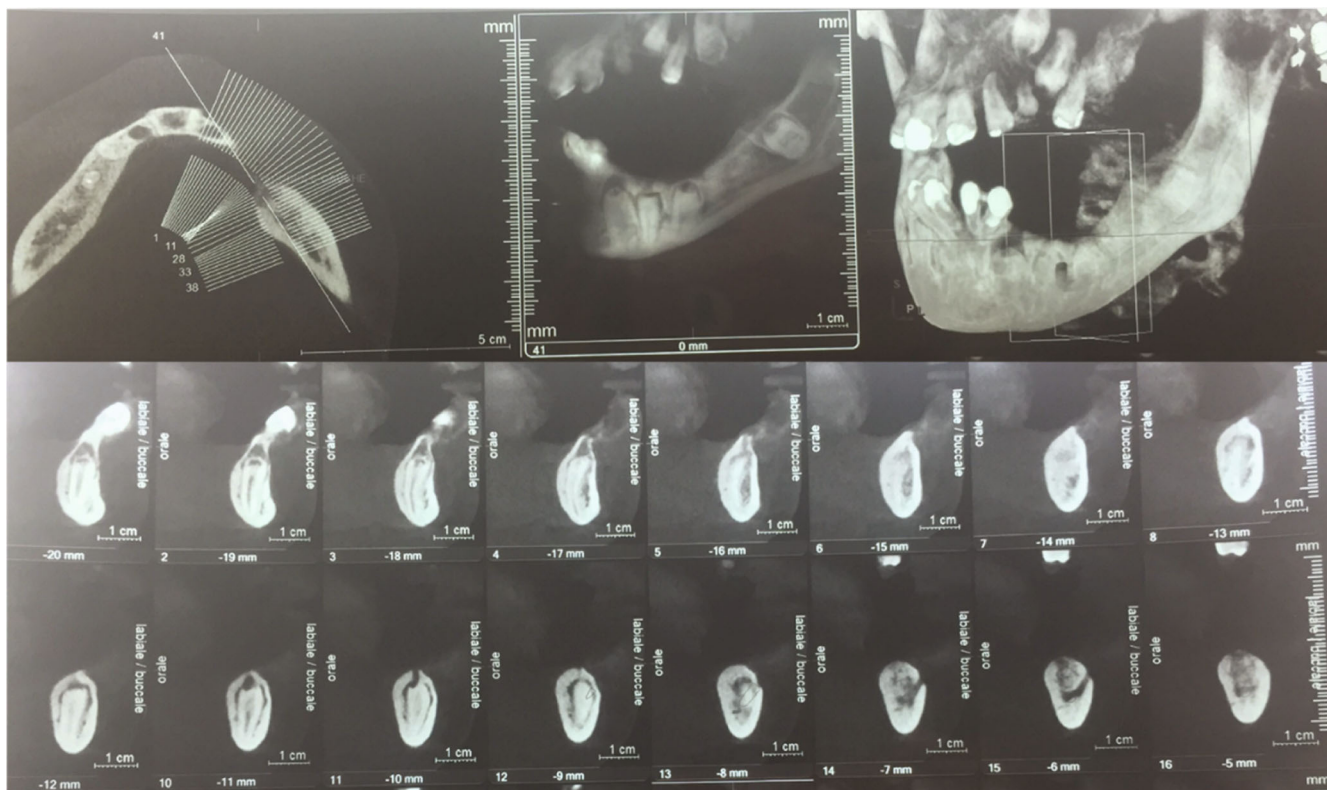
A cone-beam computed tomography (CT) scan showed that there was only a small amount of bone in the interdental spaces. Two implants (Easy System Implant, Chavanod, France), 3.7 mm in diameter, were placed using a submerged surgical procedure. One implant (11.5 mm in length) was placed between the impacted canine and the first premolar, and the other one (10 mm in length) was placed between the first and second premolars because of the proximity of

the alveolar nerve and the low quantity of bone posteriorly, as shown in Figure 3. The implants were inserted following the complete drilling sequence with abundant irrigation due to the rigidity of the dental tissues.

FIGURE 3: Cone-beam CT scan showing a small amount of bone only in the interdental spaces.

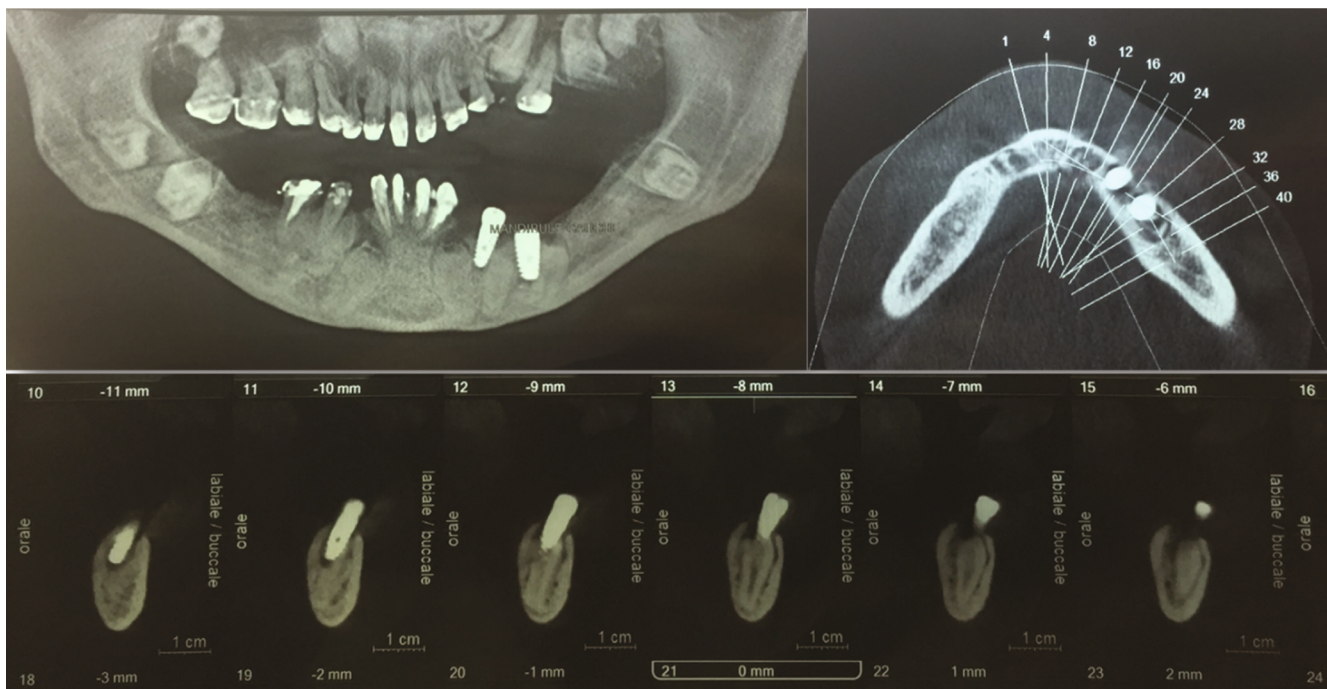
The healing process after surgery was uneventful. One month later, we noticed gingival dehiscence with exposed threads of the first implant (implant placed in the canine position) and slight mobility on contact with no pain or swelling. A cone-beam CT scan showed bone loss around the implant with no reduction in peri-implant bone height; it was like the implant had exfoliated from its socket. The second implant, however, was well integrated with the bone and dental tissue (Figure 4).

FIGURE 4: Cone-beam CT scan showing an exfoliation and bone loss around the implant placed between the impacted canine and the first premolar. The second implant placed between the first and second premolars is integrated into the bone and dental tissue in contact.

(1) The implant was put in contact only with the enamel of the impacted tooth; however, histological data reported a possible mineral reaction only if the implant surface had an interface with dentin or cement [15, 16]. These findings agree with those reported by Davarpanah and Szmukler-Moncler, in which a short implant placed in contact with the enamel of an impacted canine has been lost. The authors suggested the use of a longer implant to pass through the dentin and pulp chamber [8].

(2) The implant was not surrounded by enough bone, especially in the cervical and apical parts. This

is why, when it was placed deeper, we found better osteointegration.

The failed fixture was removed, the surgical site was rinsed with chlorhexidine 0.12%, and an immediately wider-bodied fixture (4 mm in diameter and 11.5 mm in length) was placed deep through the impacted teeth following the same osteotomy site (Figure 5).

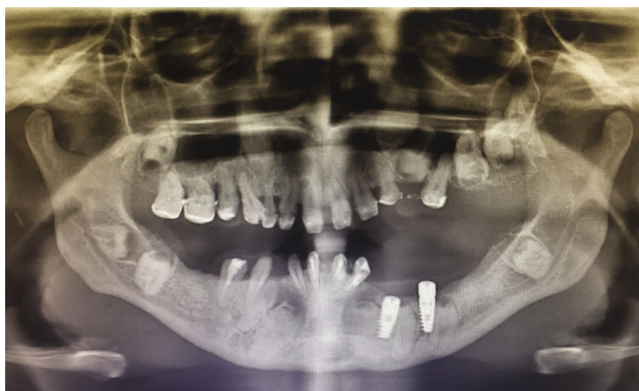
FIGURE 5: Panoramic radiograph showing wider fixture placed deep through the impacted canine and first premolar.

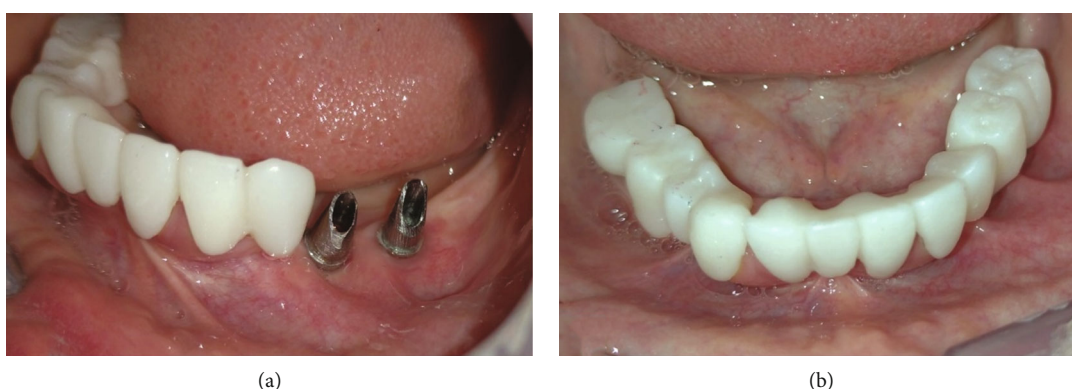
performed in association with a custom screw-retained abutment to improve the emergence profile of the crowns (Figure 6).

FIGURE 6: (a) Intra-oral image showing good gingival health around the abutment. (b) Occlusal view of full arch zirconia crowns.

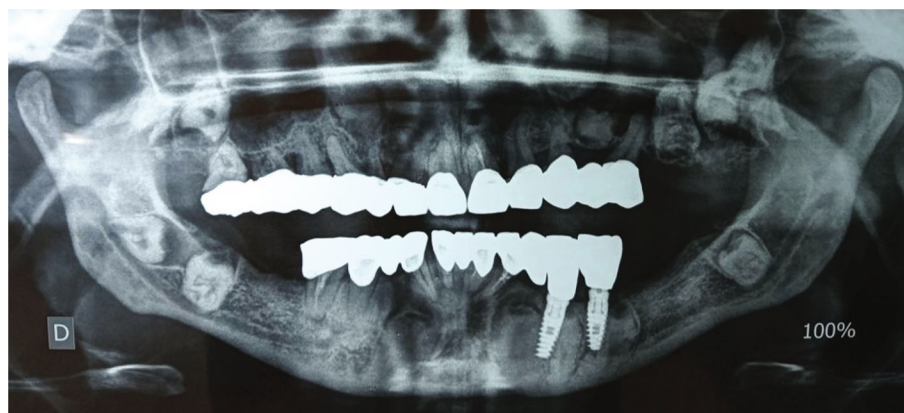
36 months of follow-up) no symptoms or signs of prosthetic or implant failure have been noticed (Figure 7).

FIGURE 7: Panoramic radiograph after 48 months of follow-up. No changes were noted around implants, impacted teeth, or bone levels.
